## BMW 3er 318d

| Stock number: | CD09899 |

# MAIN CAR DETAILS

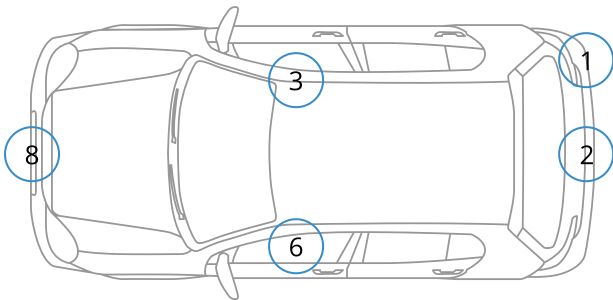
FRONT BUMPER

2 SCRATCHES

Length: ≥20mm & <50mm Surface scratch

3 STONE CHIPS

Width: ≤3mm No paint damage

HOOD
