## BMW 3er 318d GT Advantage

| Stock number: | UT00645 |

# CAR DAMAGE

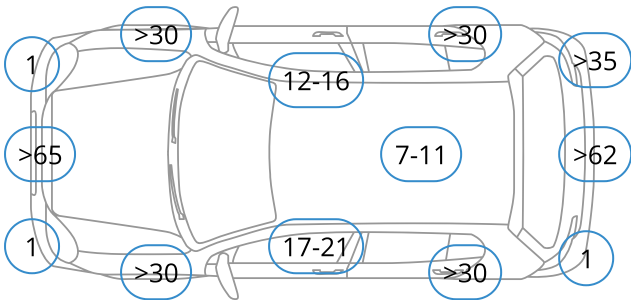
Damage and severity

FRONT LEFT FENDER

1 REPAINT

Thickness:  $\geq 125\mu\text{m}$  &  $< 250\mu\text{m}$  Professional repaint
