## BMW 3er 318d Sport Line

| Stock number: | <i>JB52751</i> |

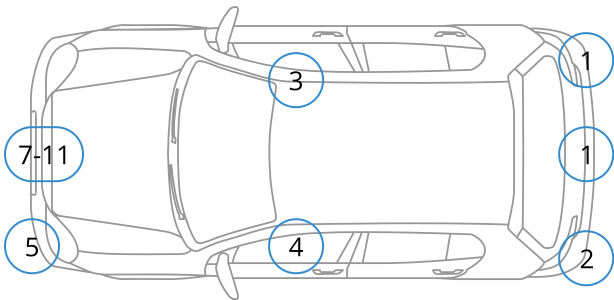
FRONT LEFT FENDER

1 REPAINT

Thickness: ≥125µm & <250µm Professional repaint

LEFT SIDE SKIRTS

4 SCRATCHES

Length: <20mm Deep scratch - down to primer
