## BMW 3er 320d xDrive Luxury Line

| Stock number: | <i>JZ32143</i> |

# CAR DAMAGE

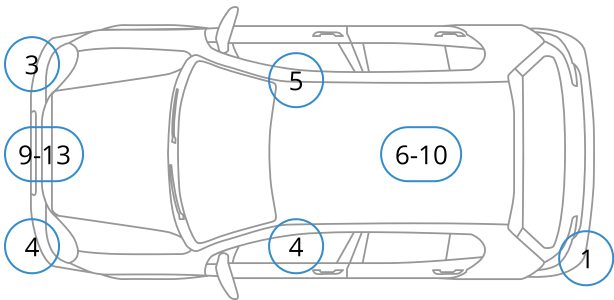
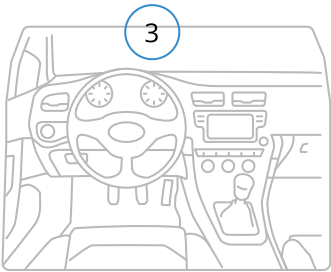
FRONT LEFT FENDER

3 SCRATCHES

Length: ≥100mm Surface scratch

1 REPAINT

Thickness: ≥250µm & <500µm Professional repaint
