## BMW 5er 525d

| Stock number: | <i>GX13348</i> |

# MAIN CAR DETAILS

# CAR DAMAGE

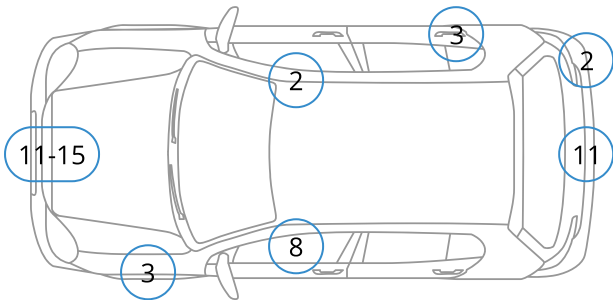
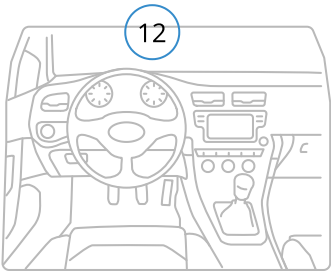
Damage and severity

FRONT BUMPER

2 FRACTURES

Length: ≥20mm & <50mm, Width: <5mm

HOOD

6-10 STONE CHIPS

Width: ≤3mm Paint damage

WINDSCREEN

3 STONE CHIPS

Width: ≤3mm Not in driver's eyeline
