## BMW 5er 530e M Sport

# MAIN CAR DETAILS

# VEHICLE CONDITION

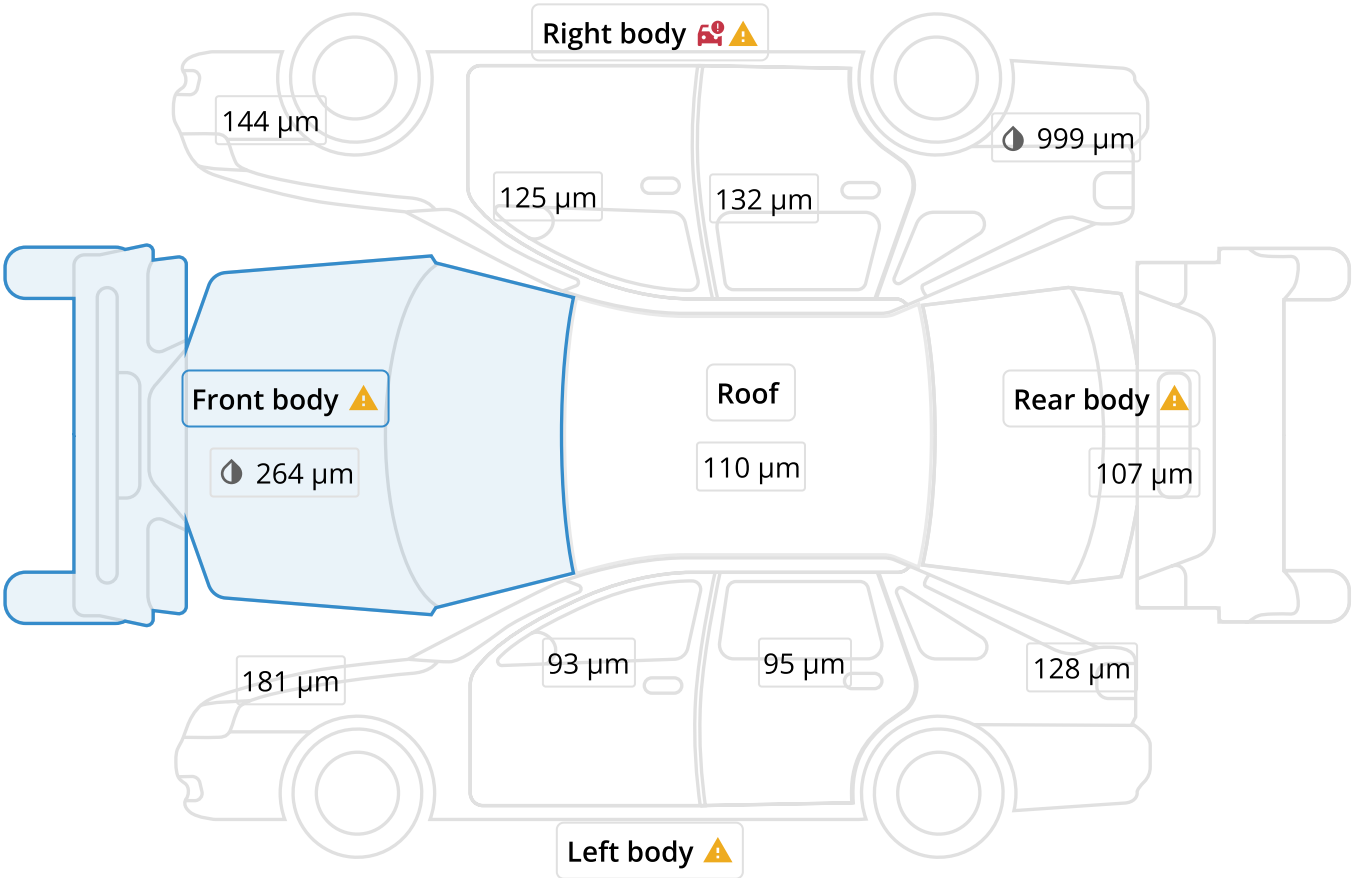
## Exterior

5 damaged areas

2 repainted panels

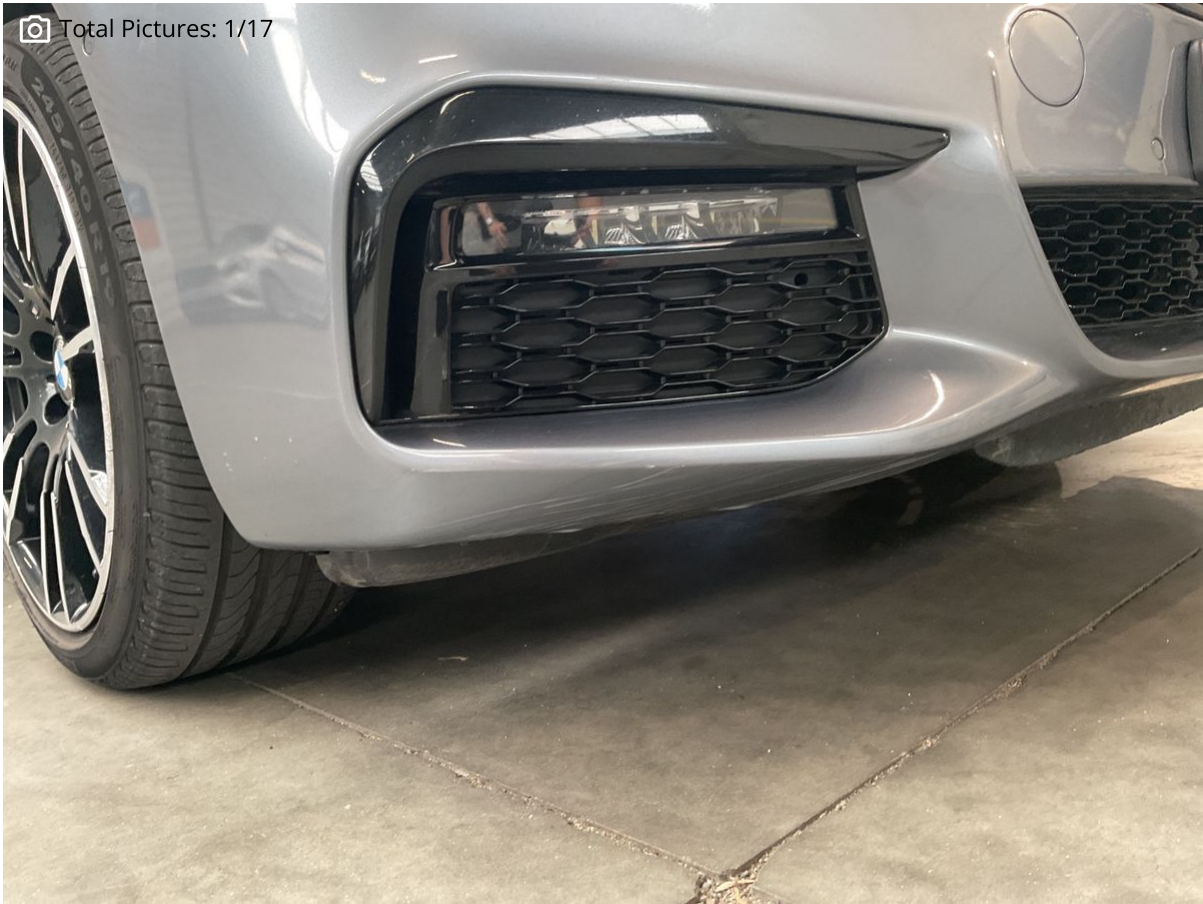
Damages

| Panel | Damage | Severity | Description | Quantity | |
| <u>Front bumper</u> | Scratch | Length:<br>≥100mm | Deep scratch -<br>down to primer | 1 | 1 |
| <u>Windscreen</u> | Stone chip | Width: ≤3mm | Not in driver's<br>eyeline | 3 | 0 |
| <u>Hood</u> | Repaint | Thickness:<br>≥250µm &<br><500µm | Professional<br>repaint | 1 | 0 |
