## BMW 4er 418d Gran Coupé Luxury Line

| Stock number: | <b>RP83794</b> |

# CAR DAMAGE

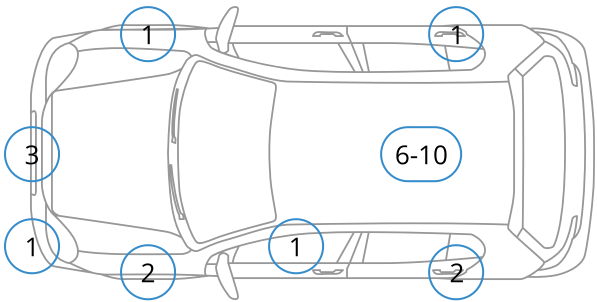
FRONT LEFT FENDER

1 SCRATCH

Length: ≥50mm & <100mm Surface scratch

| Damage / Part | Severity |
|---|---|
| <b>1 SCRATCH</b><br>Front left fender (1) | Length: ≥50mm & <100mm , Surface scratch |
