## BMW 4er 420d Gran Coupé M Sport

| Stock number: | GR62136 |

# CAR DAMAGE

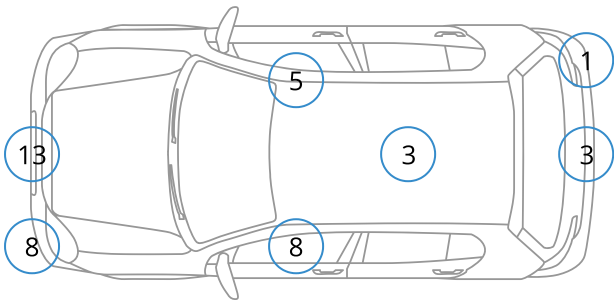
## DAMAGE AREAS

Damage and severity

FRONT LEFT FENDER

2 STONE CHIPS

Width: ≤3mm Paint damage

5 STONE CHIPS

Width: ≤3mm No paint damage

LEFT SIDE SKIRTS

1 SCRATCH

Length: <20mm Surface scratch
