## BMW 3er 320d M Sport

# MAIN CAR DETAILS

# CAR DAMAGE

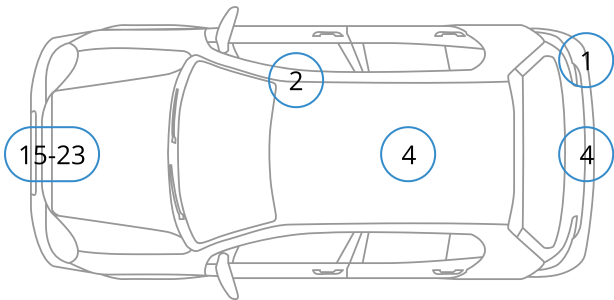
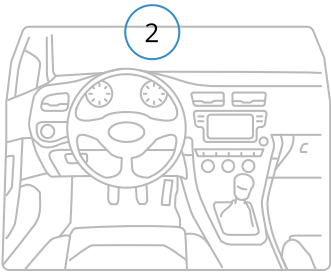
Sub-area images are merely displayed for orientation purposes and the damage summary reports the area's condition in detail. Please note that we take photos of all significant damages. Minor damage will be displayed below in the table without a corresponding image.

Deep scratch - down to primer

1/10
