## BMW 3er 320d Lounge

| Stock number: | VR10946 |

# MAIN CAR DETAILS

# CAR DAMAGE

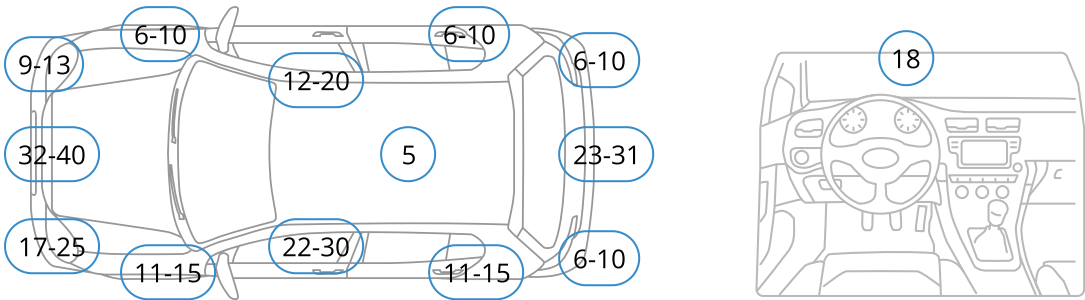
Sub-area images are merely displayed for orientation purposes and the damage summary reports the area's condition in detail. Please note that we take photos of all significant damages. Minor damage will be displayed below in the table without a corresponding image.
